## Overcoming the barriers to sustainability

The recent demolition of an office block in the City of London provides tangible evidence that environmental measures can be implemented even in the most difficult of circumstances

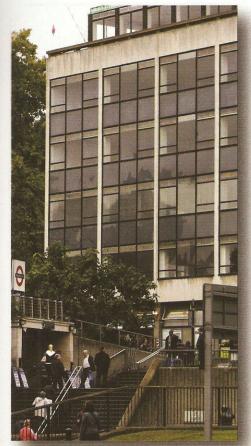
House was situated above and adjacent to Tower Hill Underground station

The south building was situated adjacent to, and directly above, Tower Hill Underground station that had to remain open and operational throughout. The contractors therefore were required to install a weatherproofed lightweight steel protection deck above the first floor slab to prevent possible debris from damaging the station's ticket hall and to ensure the safety of passengers using the main entrance directly below.

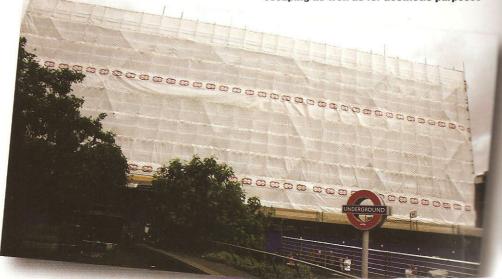
The building was covered in a tough plastic sheeting to prevent dust and debris escaping as well as for aesthetic purposes

The release of dust to the immediate environment was suppressed by encapsulating the site in translucent plastic sheeting and spraying the active workface with a fine water mist. Sound, vibration and air monitoring were carried out at regular intervals throughout the project to ensure emissions stayed within acceptable limits.
