# The reinforcements

Mechanical reinforcement techniques originally developed in the marine industry are helping to solve structural defects in low-rise apartment blocks. LABM finds out more.

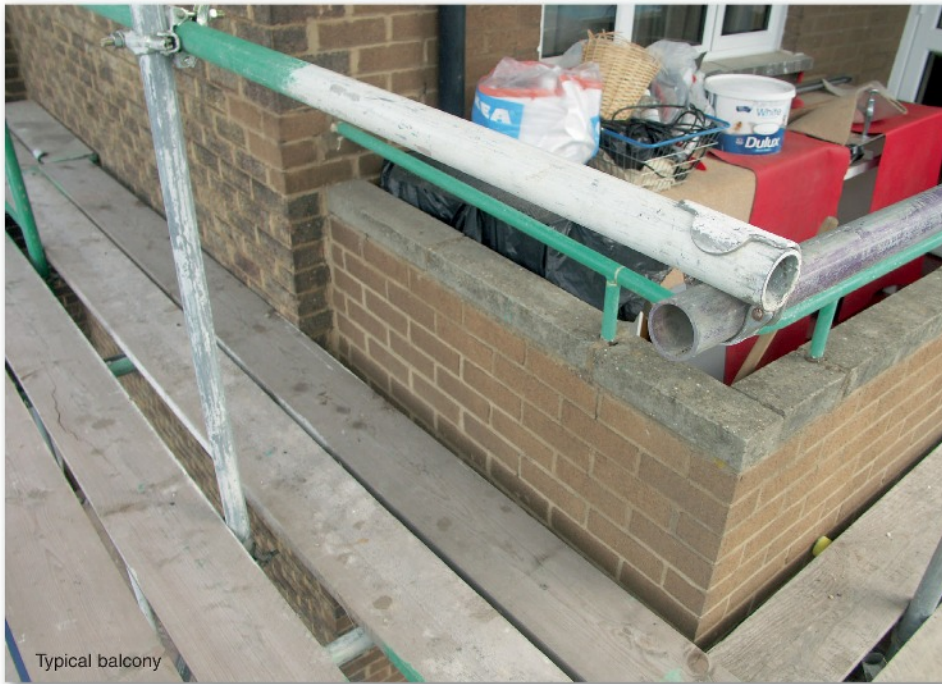
Typical balcony

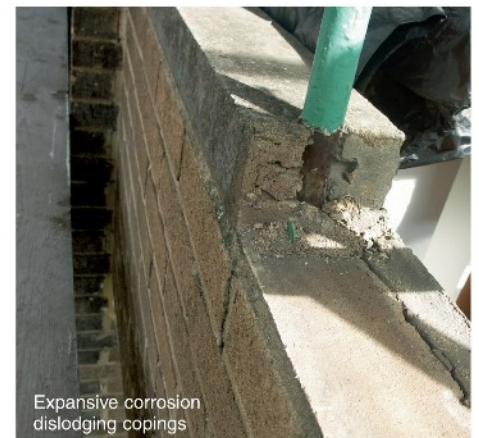
The engineers therefore concluded that the defects had been produced by moisture admitted by the brickwork that had caused corrosion of the reinforcing bars and handrail balusters. The corrosion of the

embedded mild steel reinforcing bar and handrail balusters had resulted in the formation of ferrous oxide that had expanded thus dislodging and cracking the brickwork and render around it. While there was deemed to be no immediate threat to the health and safety of the tenants, the engineers suggested that the defect would cause the balconies to eventually become unstable.

Expansive corrosion dislodging copings

The project team opted for an innovative solution proposed by structural defect-specialists, Action Wall Ties, who proposed a solution that used a combination of stainless steel and re-working the existing mild steel handrail. They suggested diamond drilling to remove the corroded baluster, further drilling the height of the wall and introducing a non-corroding stainless steel rod that would be welded to a stainless steel fixing plate. The original handrail could then be welded to the fixing plate thus providing a long-term sympathetic solution rather than a 'workaround.'

Work started in October 2010 to repair 66 defective balconies. The embedded handrail balusters were cut at coping stone line and remaining removed from the brickwork. Any damaged bricks were replaced the stainless steel fixing rods and plates, which were custom fabricated by the company, were injected with grout into a new 25mm hole created by diamond drilling the full height of the balustrade walls of the balconies. The original treated balusters were then welded to the stainless steel fixing plates ready for decoration by others.

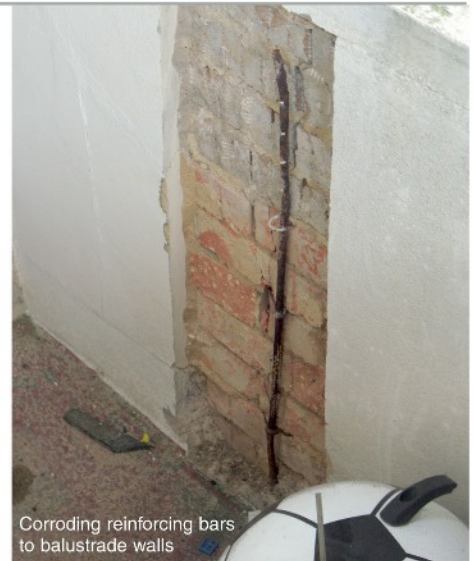
Extensive cracking, which was found in over 60 of the balconies, clearly corresponded with the reinforcing bars that were embedded in the concrete slab adjacent to the brickwork. However, generally, the external bricks and pointing were found to be in good condition with very few spalled pointing or bricks noted.

Corroding reinforcing bars to balustrade walls

The rebar reinforcing imbedded in the render was located, cut at concrete level and

removed from the wall and the disturbed area treated and the render made good. The coping stones were made good and secured with resin bonded fixings.
